# Maldives Field Survey after the December 2004 Indian Ocean Tsunami

Hermann M. Fritz,<sup>a)</sup> Costas E. Synolakis,<sup>b)</sup> and Brian G. McAdoo<sup>c)</sup>

The tsunami of 26 December 2004 severely affected the Maldives at a distance of 2,500 km from the epicenter of the magnitude 9.0 earthquake. The Maldives provide an opportunity to assess the impact of a tsunami on coral atolls. Two international tsunami survey teams (ITSTs) surveyed a total of 13 heavily damaged islands. The islands were visited by seaplane on 14–15 and 18–19 January 2005. We recorded tsunami heights of up to 4 m on Vilufushi on the basis of the location of debris in trees and watermarks on buildings. Each watermark was localized by means of a global positioning system (GPS) and was photographed. Numerous eyewitness interviews were recorded on video. The significantly lower tsunami impact on the Maldives as compared with Sri Lanka is largely due to the topography and bathymetry of the atoll chain. [DOI: 10.1193/1.2201973]

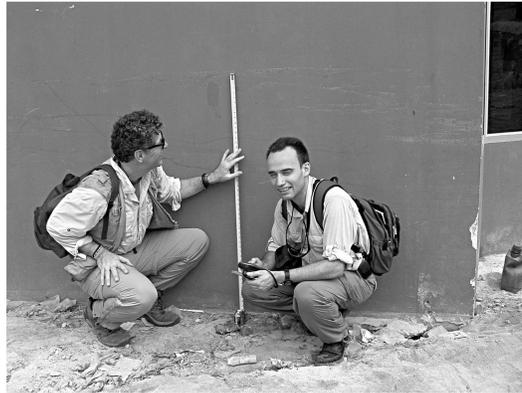
Vilufushi was completely overwashed by the tsunami. Abundant watermarks were found on the outside and inside of remaining houses as well as in the form of seaweed, clothing, and fishing nets on trees and concrete columns. Examples of tsunami flow depth measurements are shown in Figure 5.

**Figure 5.** Flow depth measurements on Vilufushi: (a) a watermark on an outside wall; (b) seaweed on a tree.

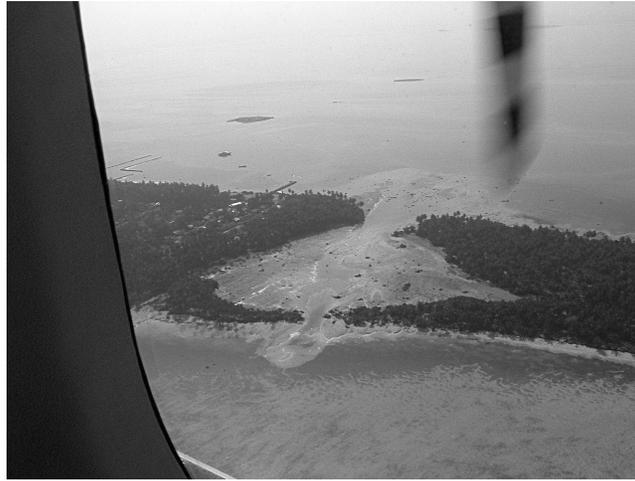
Kolhufushi is roughly 2.5 km long and 400 m wide. The transect recorded across the island indicates an even flow depth of 2 m above terrain across the entire island. The pre-tsunami satellite image shows a lagoon cutting into the island, separating the northern third from the rest of the island. The two segments were connected by a narrow sand spit covered with vegetation along the eastern shoreline of the island. The sand spit had lost its vegetation and was partially breached prior to the tsunami. However, the final breaching was induced by the overflow of the tsunami. The resulting cut separating the two island parts is shown in Figure 9, as seen from a seaplane in its final landing approach.

**Figure 9.** Westward view of the Kolhufushi lagoon and the sand spit, which was breached by the tsunami.

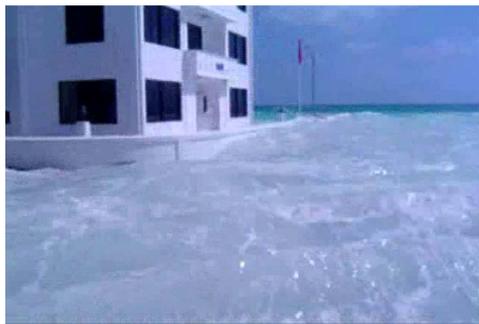
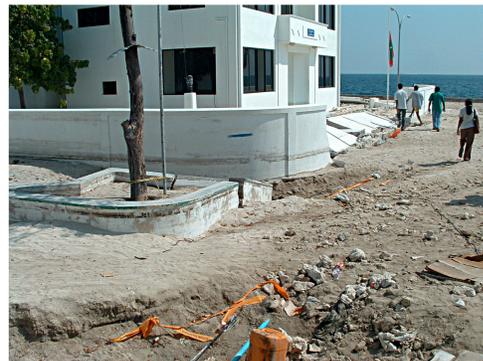
On the east side of Kandholhudhoo Island, an amateur cameraman—alerted by the phone call warning from Malé—recorded the arrival of the tsunami. Figure 12 shows a view looking east toward the center of the atoll. The amateur video shows the initial rise of the tsunami flooding the streets, similar to a rapid rise of the tides beyond normal high tide. An extracted video image during the flooding is shown in Figure 12a. At a later stage, the white wall disappeared completely underwater. The survey team revisited the exact location on 19 January 2005 and documented watermarks, a partially collapsed white wall, and massive scouring along the road corner (Figure 12b).

**Figure 12.** Amateur video at Kandholhudoo: (a) during flooding by the tsunami; (b) the same location in the aftermath, with partial wall collapse and massive scouring.
