Oman Field Survey after the December 2004 Indian Ocean Tsunami

In August 2005, a team surveyed the effects of the December 2004 Indian Ocean tsunami on the southern coast of Oman. Runup and inundation were obtained at 41 sites, extending over a total of 750 km of shoreline. Measured runup ranged from 3.25 m in the vicinity of Salalah to a negligible value at one location on Masirah Island. In general, the largest values were found in the western part of the surveyed area. Significant incidents were documented in the port of Salalah, where a 285-m-long vessel broke its moorings and drifted inside and outside the port, and another ship struck the breakwater while attempting to enter the harbor. The general hazard to Oman from tsunamis may be greatest from the neighboring Makran subduction zone in western Pakistan. [DOI: 10.1193/1.2202647]

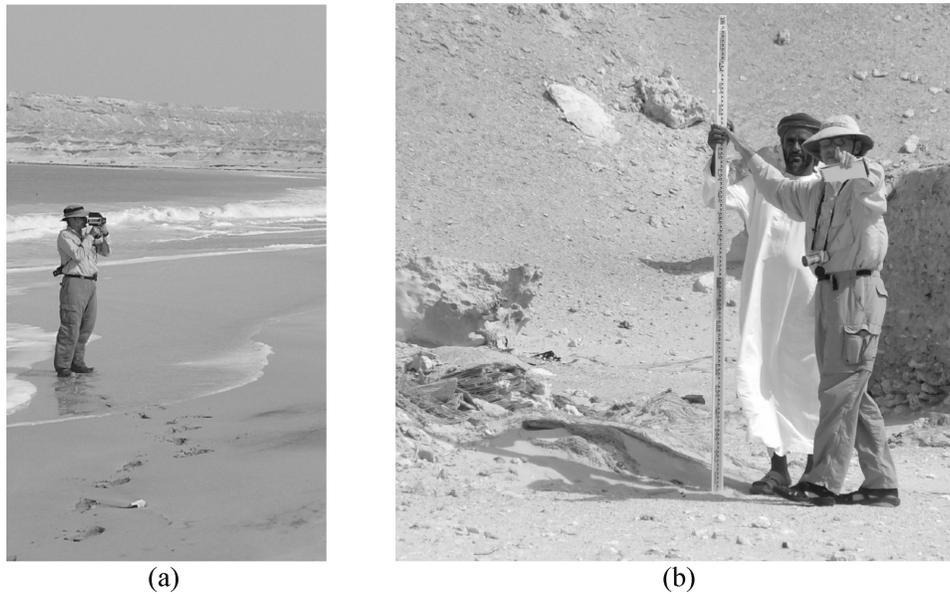
Figure 2. Surveying techniques demonstrated at Ras al Duqm (Site 31). (a) H. Fritz uses a laser ranger at the coastline. (b) 43 m away, P. Raad and tsunami eyewitness Mr. Soubayh bin Rajid bin Sa'id Al-Joubaybi identify the site of maximum penetration with a surveying rod, defining a runup of 2.6 m.

Topographic measurements were made via surveying rods and a combination of laser and eye levels (Figure 2); inundation measurements were made by laser ranging or differential GPS. An exact roster was kept of the dates and times of the individual surveys, to allow future tidal corrections, in order to relate flow depth and runup measurements to the local level of unperturbed sea surface at the time of the arrival of the tsunami.

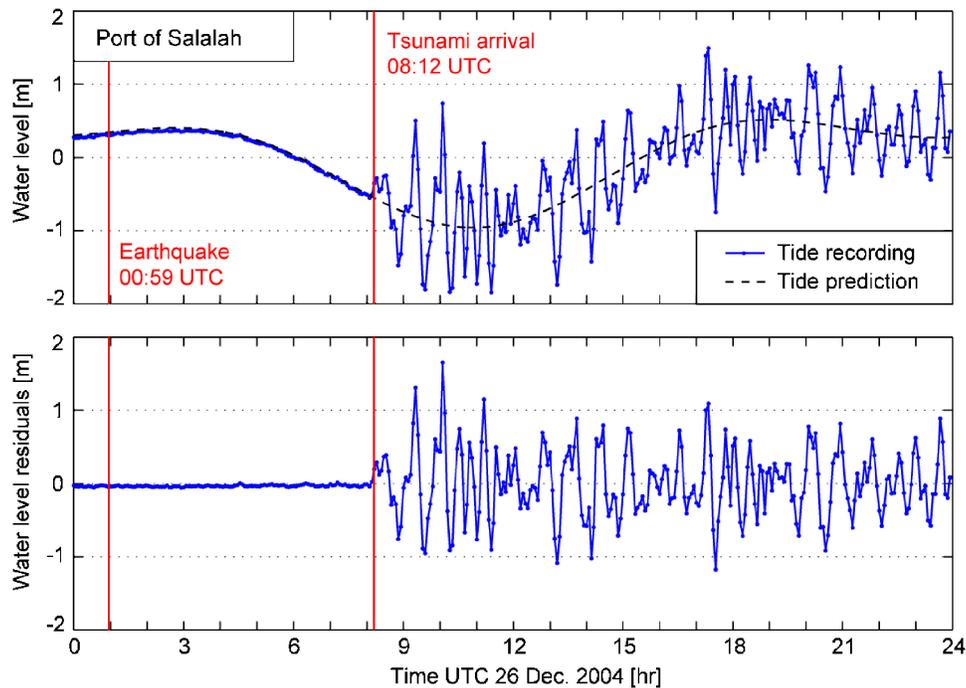
Figure 3. Maregram of the Sumatran tsunami recorded in the port of Salalah (source: University of Hawaii Sea Level Center). The top frame shows the raw data, and the bottom frame shows the tsunami signal, after the predicted tide is subtracted. Local times are 4 hours ahead of the UTC. Note the initial low-amplitude inundation, followed by a much larger downdraw, and then followed by two large positive waves. Many eyewitnesses may not have noticed the first small, positive wave.

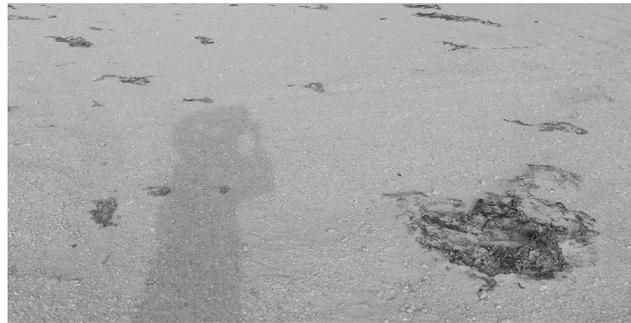
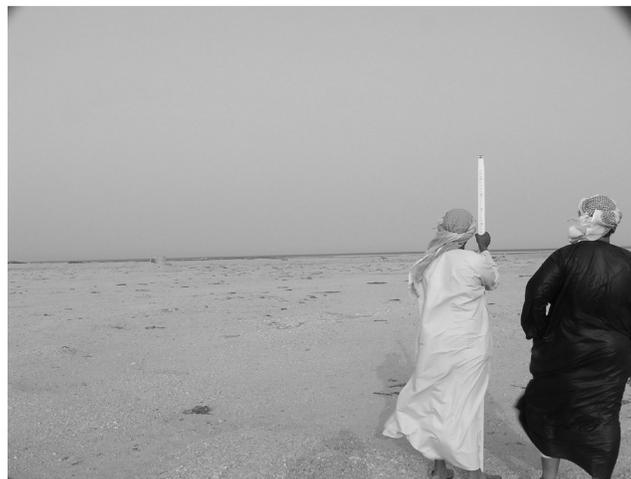
Site 40, Al Labki

Figure 4. Site 40, Al Labki. (a) On this exceptionally flat beach, the tsunami deposited algae and seaweed far inland. (b) The survey revealed an inundation of 447 m, with a runup of 2.3 m.

On this remarkably flat beach, inundation was measured at a record 447 m, for a runup of 2.3 m. The beach was strewn with marine debris and algae (Figure 4), identified by a witness as having been left by the tsunami.

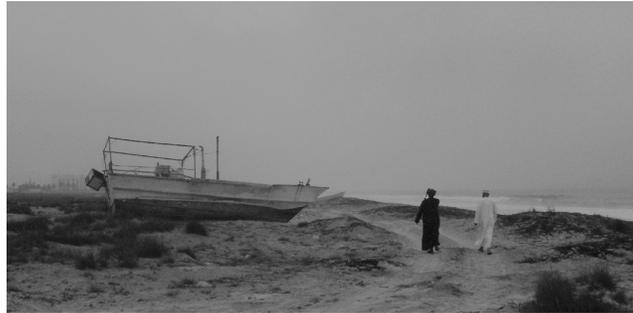
Site 4, The Beach West of Salalah

This site is located on the beach between Salalah and Rasyut, a few kilometers west of the Hilton Salalah Hotel and Resort, barely discernible in the background of Figure 5. Eyewitnesses led us to a 10-m-long fishing boat that the tsunami had deposited on the sand berm. Flow depth was estimated from the flotation line of the boat at a minimum of 3.1 m; runup was 3.25 m, 36 m farther inland, on the basis of marine shell deposits. Except for the splash at Site 34b, this constitutes the largest runup value in the survey.

Figure 5. Site 4, the beach between Salalah and Raysut. This 10-m fishing boat was moved by the tsunami to the top of the berm, 35 m from the shore. On the basis of the flotation line of the boat, flow depth at that location was computed at 3.1 m; watermarks are preserved another 36 m inland. In the distance to the left of the boat is the Hilton Hotel and resort, and to the right of the prow is a smaller fishing boat, reportedly also deposited by the tsunami.

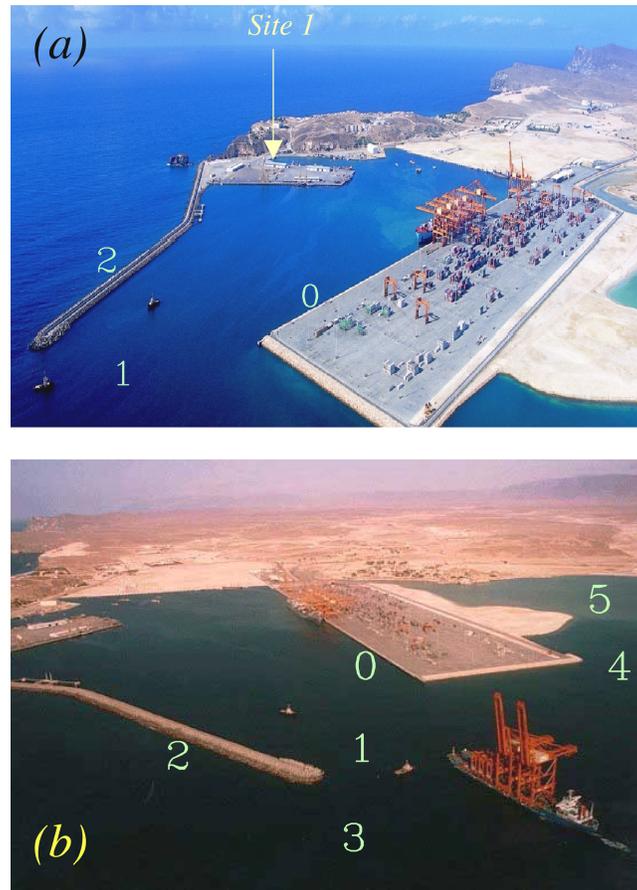
The Port of Salalah is one of the major container terminal facilities in the Middle East. In Figure 6 are two file photos of the port that show the main wharf, which offers four berths capable of accommodating the largest container ships. According to reports obtained from the harbor master, Captain Ahmed Abdullah, the manager of marine services, Captain Geerd Gunther, and several other port employees, the 285-m freighter *Maersk Mandraki*, which was docked at Berth 4 (Figure 7a), broke its moorings at 1:42 P.M. (09:42 UTC) and started drifting for a period of several hours. It drifted both inside the harbor, where it was caught in a system of eddies from which all efforts to free it via tugboats were in vain, and outside the port itself, where the ship reached the far side of the breakwater before eventually returning toward the harbor and beaching on a sand bar to the east of the main wharf (Figure 7b).

Figure 6. Aerial file photos of the Port of Salalah (source: www.salalahport.com). (a) Looking west-southwest; also shown is survey Site 1 in the old port. (b) Looking west-northwest. In both these photos, overprinted numbers are keyed to the description of the path of the *Mandraki* (Figure 7b) after the ship broke its moorings at Berth 4 (position 0 in both photos).

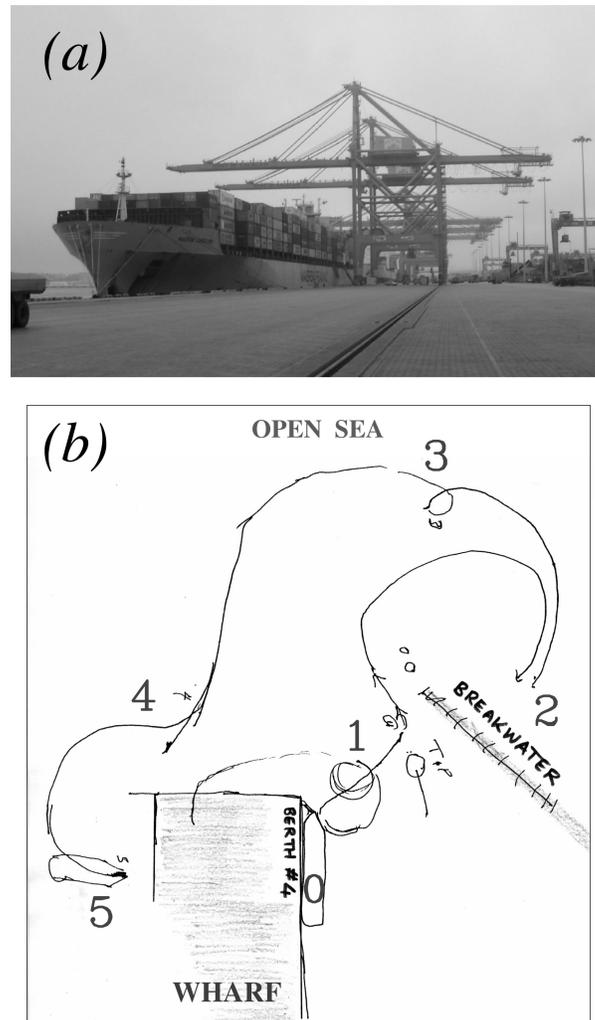
Figure 7. (a) The *Maersk Carolina* moored at Berth 4 on 14 August 2005. This is a sister ship of the *Virginia* and is also essentially comparable to the *Mandraki*. (b) A hand-drawn sketch by the eyewitness, looking east-northeast (out to sea) and detailing the drift of the *Mandraki*. The numeral 0 shows the initial position of the *Mandraki* moored at Berth 4, 1 shows the ship caught in a strong eddy after the rupture of its moorings, 2 shows the ship outside the harbor approaching the far side of breakwater, 3 shows the subsequent loop outside the harbor, 4 shows the return to the harbor, and 5 shows the eventual grounding on a sand bar east of the harbor.

Of the three incidents, the one in Salalah was probably the most spectacular, as it involved two marine behemoths rendered essentially uncontrollable for several hours in the midst of critical port infrastructure—involving, in particular, giant hydrocarbon storage facilities. A lesson to be heeded from such incidents is that the hazard posed by the arrival of a distal tsunami in the harbor of a coast that is otherwise largely spared by the wave may last much longer and even start much later than the more conventional inundation of a beach. It will certainly warrant the reassessment of civil defense policies in port facilities, in particular concerning the very sensitive issue of the “all clear” message, which may have to be significantly delayed in a harbor environment.
