Somalia Field Survey after the December 2004 Indian Ocean Tsunami

Hermann M. Fritz^{a)} and Jose C. Borrero^{b)}

The 26 December 2004 tsunami severely affected Somalia, with some 300 deaths at a distance of 5,000 km from the epicenter of the magnitude 9.0 earthquake. Somalia's physical characteristics allowed a detailed assessment of the far-field impact of a tsunami in the main propagation direction. The UNESCO mission surveyed five impacted towns south of the Horn of Africa along the Puntland coast in northern Somalia: Eyl, Bandarbeyla, Foar, Xaafuun, and Bargaal. The international team members visited Somalia during 2–10 March 2005. The team measured tsunami runup heights and local flow depths on the basis of the location of watermarks on buildings and eyewitness accounts. Maximum runup heights were typically on the order of 5–9 m. Each measurement was located by means of global positioning systems (GPS) and was photographed. Numerous eyewitness interviews were recorded on video. [DOI: 10.1193/1.2201972]

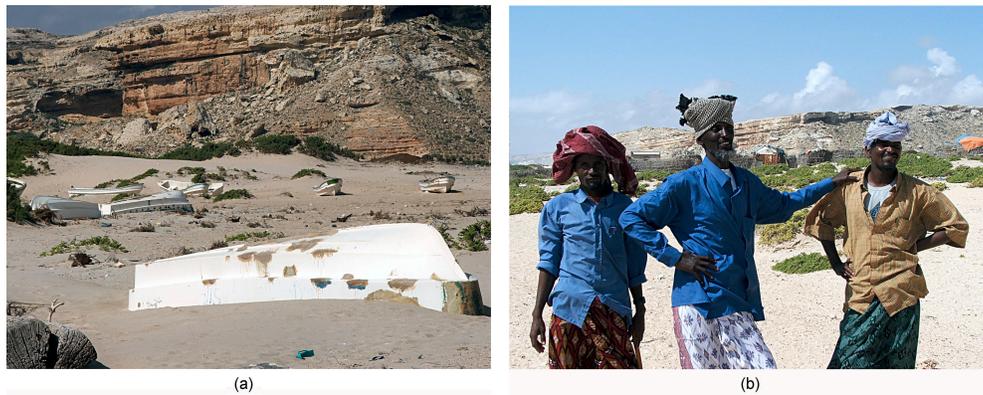
Figure 4. Eyl: (a) fishing boats scattered by the tsunami in the sand dunes north of the town; (b) elders at the maximum runup location; typical stick huts are at the bottom of the 100-m-tall cliff.

The beaches in Eyl, with 3–5% slopes, are among the widest along the Puntland coast, because of the river mouth. In the area north of the river entrance, fishing boats were scattered up to 200 m inland and up to an elevation of 5 m (Figure 4a). The tsu-

nami destroyed 40 fishing boats and damaged 70 more out of a total of 145 boats in Eyl. The survey team had to rely mostly on the elders of Eyl and their eyewitness accounts to identify the maximum inundation and runup (Figure 4b). The two recorded transects are shown in Figure 3. North of the Eyl River entrance, a 6-m runup was measured, whereas just south of the river, the highest runup of over 9 m was recorded at the foot of the cliff; the latter runup height is based solely on an eyewitness account. No physical evidence was identified at the 9-m runup point, but some sponges were found along the profile at a 6-m elevation. The well-built houses of Eyl along the foot of the cliffs at more than a 10-m elevation were not inundated. The fishing cooperative built in 1975 was not flooded by the tsunami.

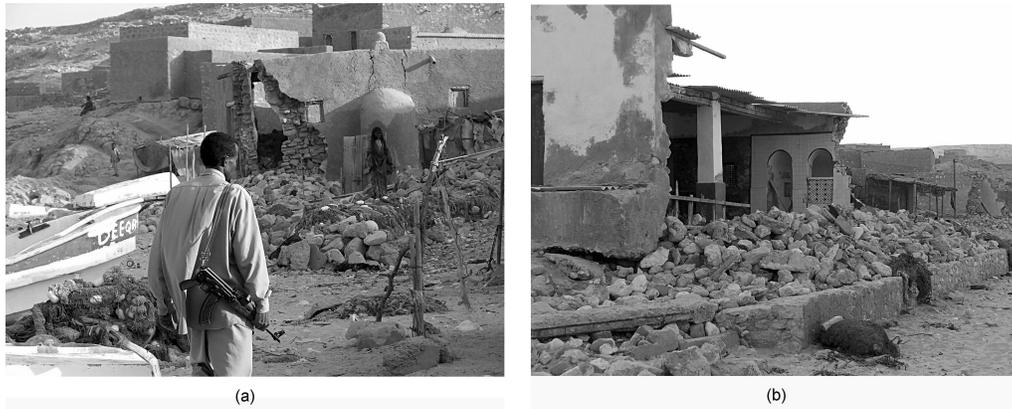
Figure 6. Bandarbeyla: (a) a destroyed rock house corner and an armed bodyguard leading the way; (b) blowout failure of walls parallel to the shoreline.

Most houses in Bandarbeyla were solidly built of rocks, in sharp contrast to the characteristic stick huts of the nomads. Numerous house walls parallel to the shoreline were pushed in, and house corners collapsed due to local scouring. Rock houses severely damaged by the tsunami along the steep shore in Bandarbeyla are shown in Figure 6. The loss of 120 fishing boats was reported. The remains of fishing boats were found amidst the rubble of collapsed houses at elevations of up to 8 m (Figure 7a). The sur-

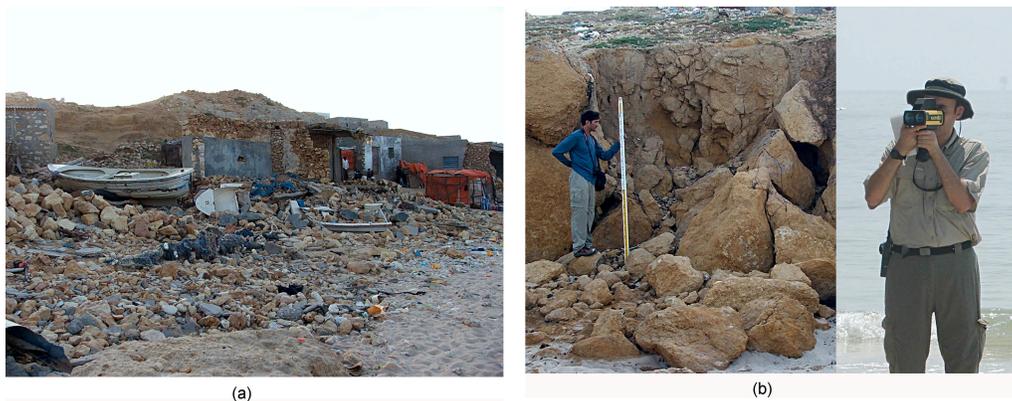
Figure 7. Bandarbeyla: (a) boats smashed ashore amidst house rubble; (b) surveying of shore erosion with a laser rangefinder.

veying was conducted with some difficulties, because armed guards were needed to control a hostile mob that gathered at the scene. A laser rangefinder with bearing and inclination modules combined with a GPS allowed a rapid recording of several transects, as shown in Figure 7b, during the surveying of shore erosion at the southern end of Bandarbeyla. The seven recorded runup points are shown in Figure 5. The runup scattered around 6 to 9 m, and the inundation distance varied from 40 to 60 m. The beaches in Bandarbeyla sloped from 10% to 20%.

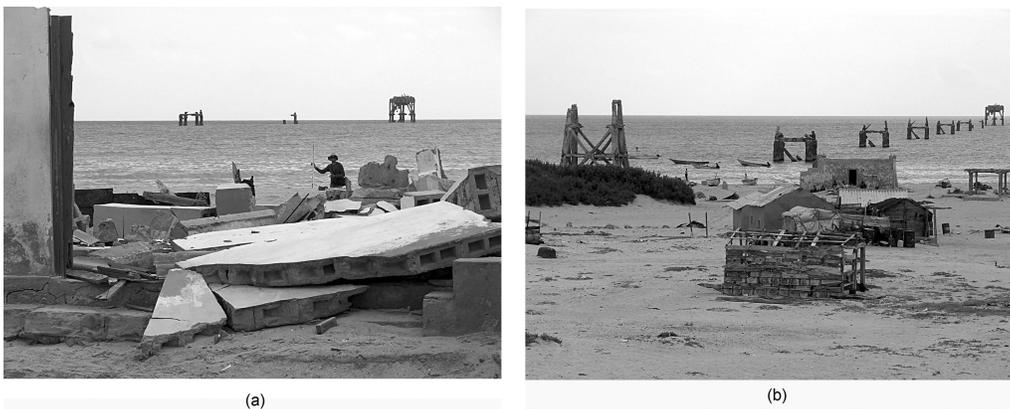
Figure 10. Xaafuun: (a) a destroyed mosque and cement stone houses; (b) a pier of an Italian salt factory that had been destroyed during World War II.

A total of 812 houses were destroyed, including 600 stone houses, and an additional 400 houses were reported to be damaged. Figure 10a shows the survey team recording a transect amidst the destroyed mosque and collapsed cement stone houses. Most houses in Xaafuun were built of rocks and cement stones. Numerous house walls parallel to the

Indian Ocean. The Italian-speaking vice council, Mahad X. Said, standing at the waterfront outside the mosque upon the arrival of the tsunami (Figure 10a), gave a very detailed description of the initial wave sequence. At first, a 100-m drawback was noticed, followed by a first wave flooding the beach. Next, the water withdrew again by 900 m before the second wave partially flooded the town. Finally, the water withdrew again by 1,300 m offshore before the third and most powerful wave washed through the town. These drawbacks correspond to 0.5-m, 4-m, and 6-m depths. The detailed eyewitness account of the numerous drawbacks is founded on the locations of the offshore pillars. The velocity of the third wave closing in on the town was approximately 11 m/sec. This estimate is based on distances determined from the offshore pillars and the time interval
