Sri Lanka Field Survey after the December 2004 Indian Ocean Tsunami

An International Tsunami Survey Team (ITST) consisting of scientists from the United States, New Zealand, and Sri Lanka evaluated the impacts of the 26 December 2004 transoceanic tsunami in Sri Lanka two weeks after the event. Tsunami runup height, inundation distance, morphological changes, and sedimentary characteristics of deposits were recorded and analyzed along the southwest and east coasts of the country. Preliminary results show how local topography and bathymetry controlled the limits of inundation and associated damage to the infrastructure. The largest wave height of 8.71 m was recorded at Nonagama, while the greatest inundation distance of 390 m and runup height of 12.50 m was at Yala. At some sites, human alterations to the landscape increased the damage caused by the tsunami; this was particularly evident in areas of coral poaching and of sand dune removal.

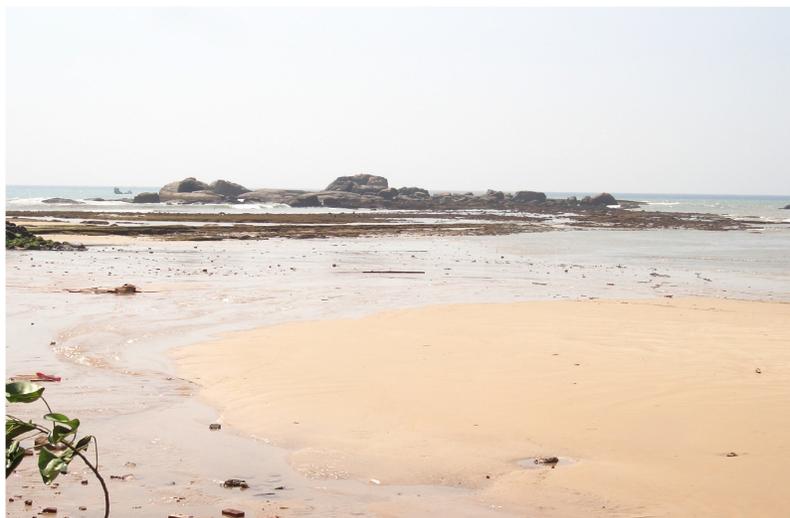
Figure 3. Hikkaduwa: receding ocean. A diver took this photo minutes before a large positive wave arrived. The wreck to the left of the rock outcrop is barely visible on a normal day.

The tsunami first arrived on the eastern coast and subsequently refracted around the southern tip of Sri Lanka (Dondra Head). Refracted waves inundated the southwestern part of Sri Lanka with varying intensity, depending upon local topography and beach defenses. The first signs of the tsunami observed by the Sri Lankan public was a negative wave, although a smaller positive wave arrived first. The ocean receded by as much as 1 km in some areas (Figure 3). This was followed by a large positive wave.

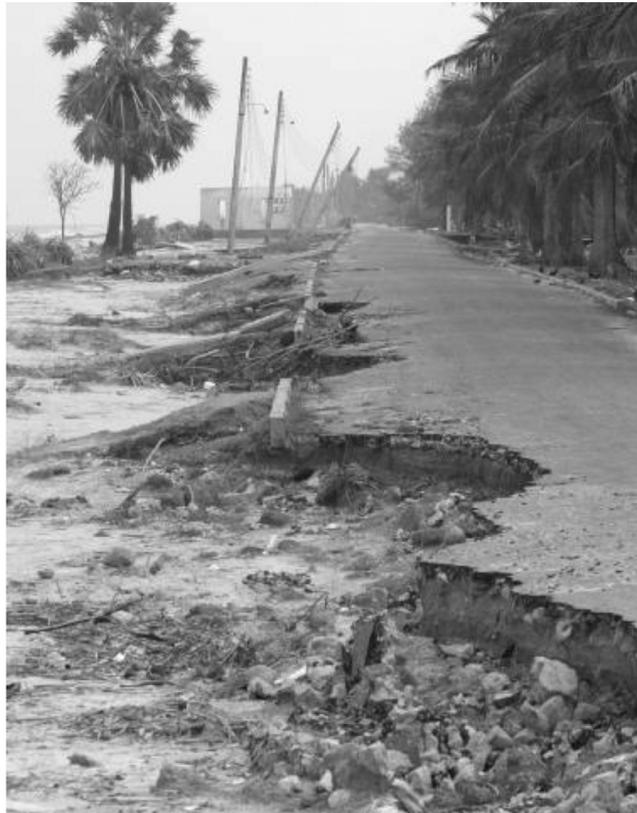
Figure 4. (a) Kattankudi: coastal roads in this area were notched and in some places completely removed. At this location, the surveyed inundation was about 700 m, with maximum elevations of less than 4 m. (b) Karativu: here, house rubble is used to rebuild a completely eroded coastal road.

Damage to engineering lifelines in the inundation zones was catastrophic. Reconstruction in the immediate aftermath has been variable. About 690 km of the national road network was damaged, in addition to 1,100 km of provincial roads. The main road south from Colombo reopened within three days of the tsunami, whereas roads on the east coast were still seriously compromised at the time of the ITST visit (Figure 4).

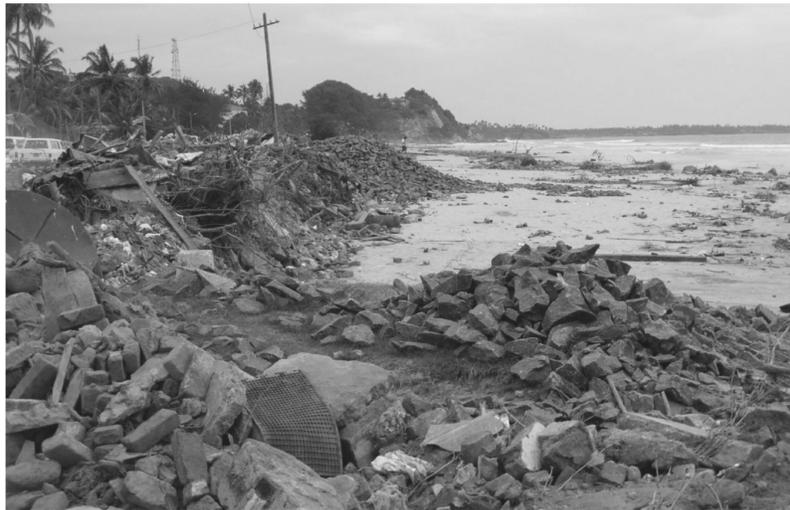
Figure 5. (a) Matara: debris was pushed into the intertidal zone to clear roads and streets. (b) Hambantota: debris that was pushed into rivers and wetlands has implications for contamination of surface and groundwater resources.

In most cases, the personnel performing emergency clearance of roads and land saw haphazard disposal of debris along the roadside (Figure 5), into open fields, and into drainage ditches; where the road ran adjacent to the sea, material was pushed onto the beaches into the intertidal zone (Figure 5). When pushed onto beaches, much of the debris has been remobilized and incorporated into the near-shore transport zone; in wetlands and ditches, this led to the possibility of groundwater contamination.

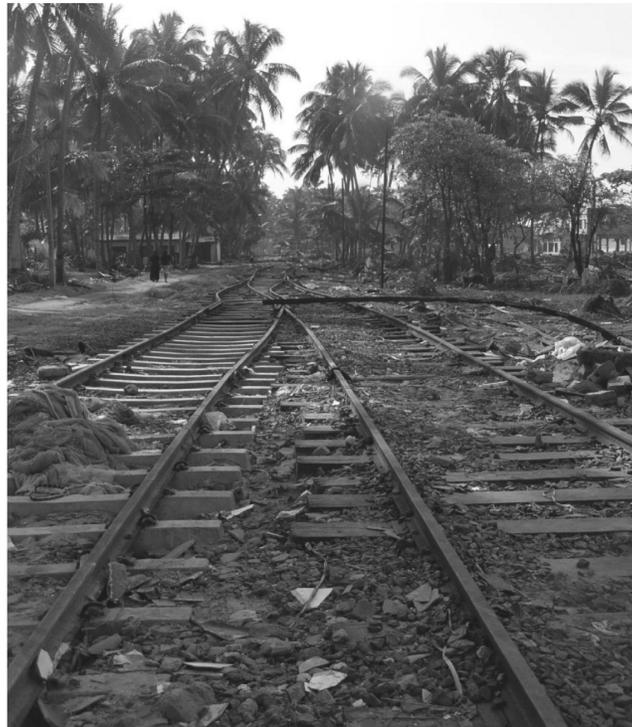
Figure 6. Payagala: (a) tracks bent inland (from right to left) by the tsunami; (b) damage to the railway station.

The tsunami caused an estimated US \$15 million of damage to the southern rail corridor, with the majority of the damage affecting the track and infrastructure to the south of Kalutara (ADB et al. 2005). Much of the railway was destroyed through bridge or rail damage and scour (Figure 6).

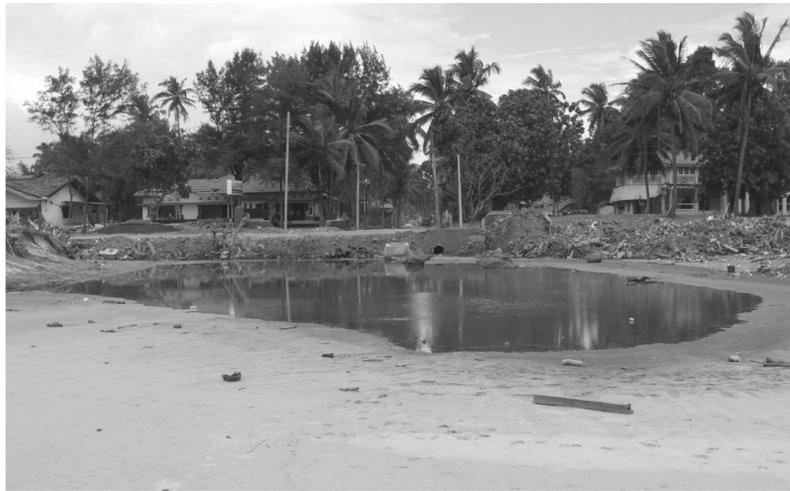
Figure 7. (a) Matara: recently repaired backwash scour of a drainage channel and beach. (b) Nintavur: the tsunami scoured around and then transported a cement well casing.

deep scour channels that favored topographic lows or places where structures concentrated the flow. In many cases, this led to scouring around and under buildings or the complete removal of stormwater culverts (Figure 7).

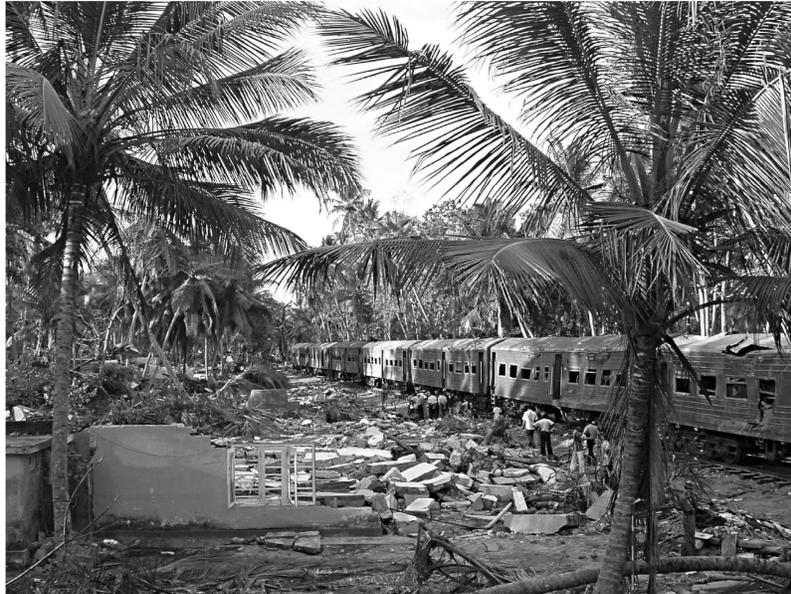
Figure 8. Peraliya: the “Queen of the Seas” train after being placed back onto the tracks (photo: Synolakis et al.).

Damage from the tsunami was more marked at sites where there had been some degree of human disturbance of the environment. In the case of Peraliya, illegal coral mining has been shown to have created “low-resistance” pathways that allowed focused flow and intensified destruction, leading to the large loss of life experienced by the derailment of the “Queen of the Seas” train (Fernando et al. 2005) (Figure 8).

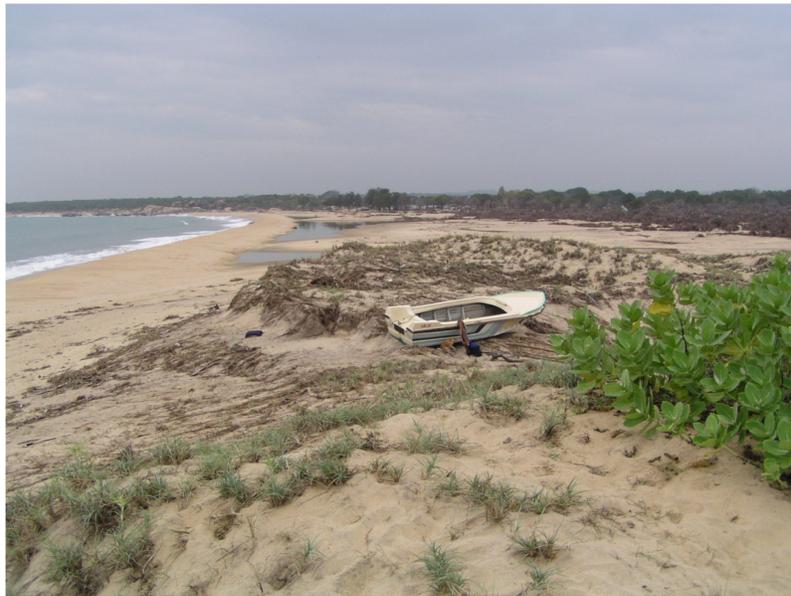
In Yala, removal of dunes seaward of a resort hotel led to complete destruction of the development, with inundation and runoff far greater than in areas behind adjacent unaltered dunes (Liu et al. 2005) (Figure 9).

Figure 9. (a) Yala: looking west from the unaltered high dune toward the area previously occupied by the Yala Safari Beach Hotel. The tsunami runup barely overtopped the unaltered dune in the foreground, depositing a boat near the top, but destroyed the hotel and most of the vegetation in the middle distance. (b) Yala: live vegetation in the lee of the unaltered dune.

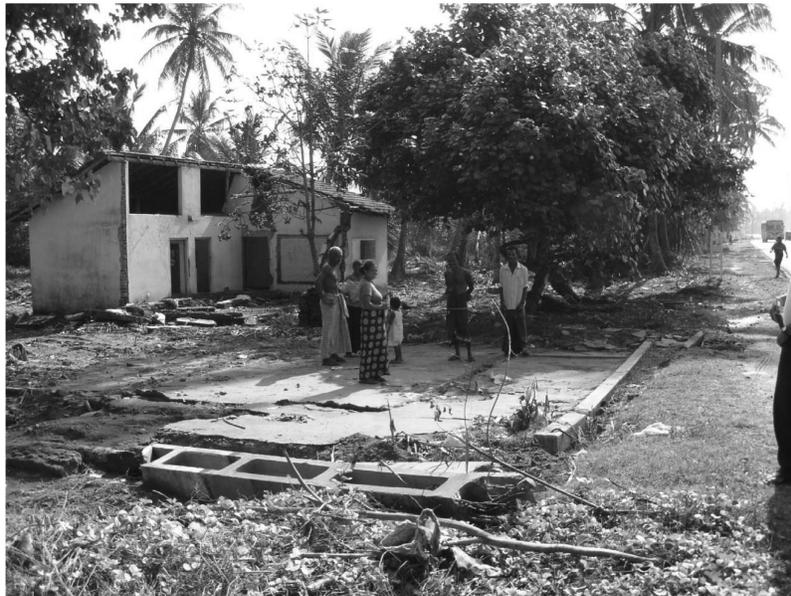
Figure 10. (a) Boosa: a partially destroyed house on the landward side of the road. (b) Telwatte: little remains of poorly constructed houses on the seaward side of the road.

the railway or road), where damage was less severe (Figure 10), but in areas in which they were located close to the sea and tsunami inundation was severe (the east and south coasts in particular), destruction was also complete or severe.

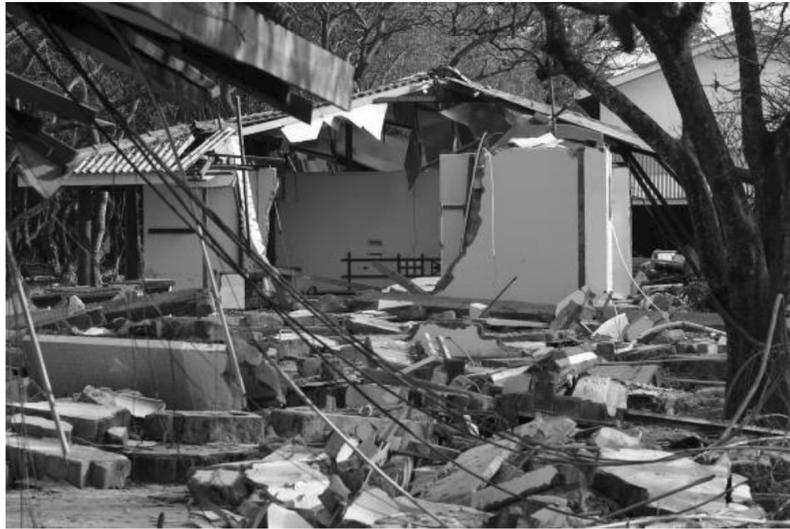
Figure 11. (a) Nilavelli: this resort was heavily damaged by the tsunami despite relatively good construction standards. (b) Weligama: houses landward of the destruction remained intact, while those seaward took the full force of the tsunami.

Extensive areas of debris or cleared land gave an indication of the large number of buildings that had been destroyed (Figure 11). Those that remained standing within the inundation zone appeared to have been either well sheltered by other buildings or were well tied at their foundation levels.
